PRACTICAL CASE

USTER® QUANTUM EXPERT 3 provides data to identify root cause of thin places

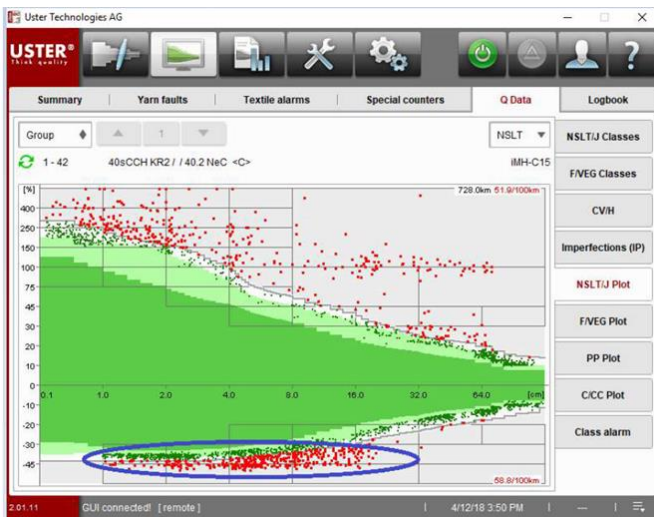
In a spinning mill producing 100% cotton yarn with a capacity of 35,000 spindles staff observed a sudden increase of the number of cuts in the yarn caused by thin places (Fig. 1). In the process of checking all relevant factors it showed that the settings of the ring spinning machine and the pre-spinning machine were the same. It also came to light that the material from other ring spinning machines did not show these defects. An exchange with cops from other ring spinning machines made it obvious that the problem only happened with one particular ring spinning machine.

Fig. 1: Yarn Body™ showing a high number of thin places.

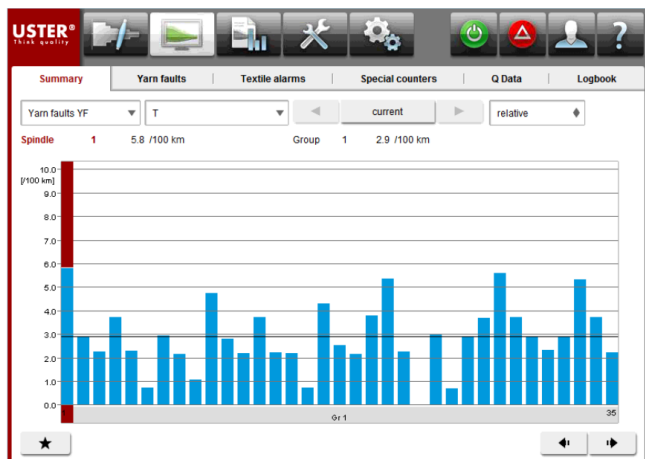
Fig. 3: 3 T-cuts/100 km before the problem started.

- comparing the number of T-cuts/100 km before and after the problem occurred (Fig. 3 and 4)
- the fact that there was no difference or abnormality found in the settings in that particular ring spinning machine.

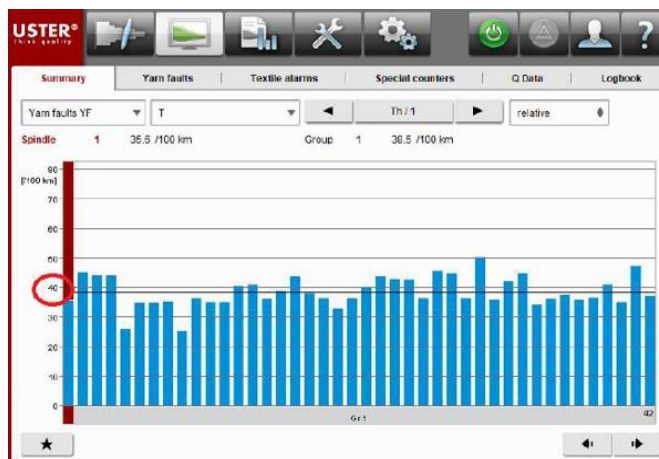
Fig. 4: 36 T-cuts/100 km after the problem started.

The analysis helped in finding a direct correlation between the ring spinning machine run-stop diagram and increased number of cuts. The ring spinning machine was restarted when the power was back and it was observed that the cuts caused by thin places had increased. The reason was the program had got corrupted and as a result, it had triggered a change in the roller speed in the ring spinning machine.

Further, it caused a mismatch between the delivery speed and the spindle speed in the start up phase of every doff. Due to this, thin places continued to occur on a few meters of yarn on all cops but on every doff. On a positive note, the whole cop remained unaffected by the draft change since the problem occurred at the beginning of the doff.
