PRACTICAL CASE

How a spinner found three major benefits from USTER® RSO 3D

Rapid identification of potentially damaging faults – and pinpointing the root causes – resulted in significant gains in productivity and quality control for this spinner.

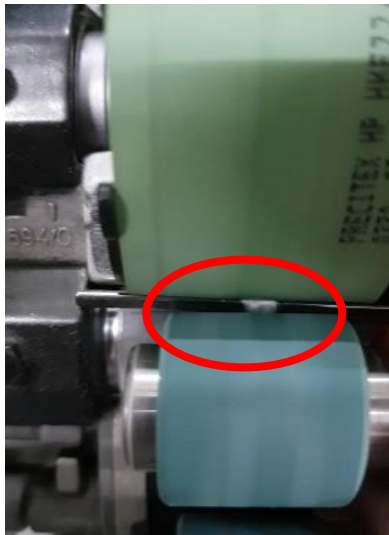
After receiving the results from the laboratory, a service technician checked spinning position 336 and discovered that the roving was misguided, going above the pin bar spacer instead of underneath (Fig. 1).

Fig. 1: The roving was misguiding, going above the pin bar spacer instead of underneath.

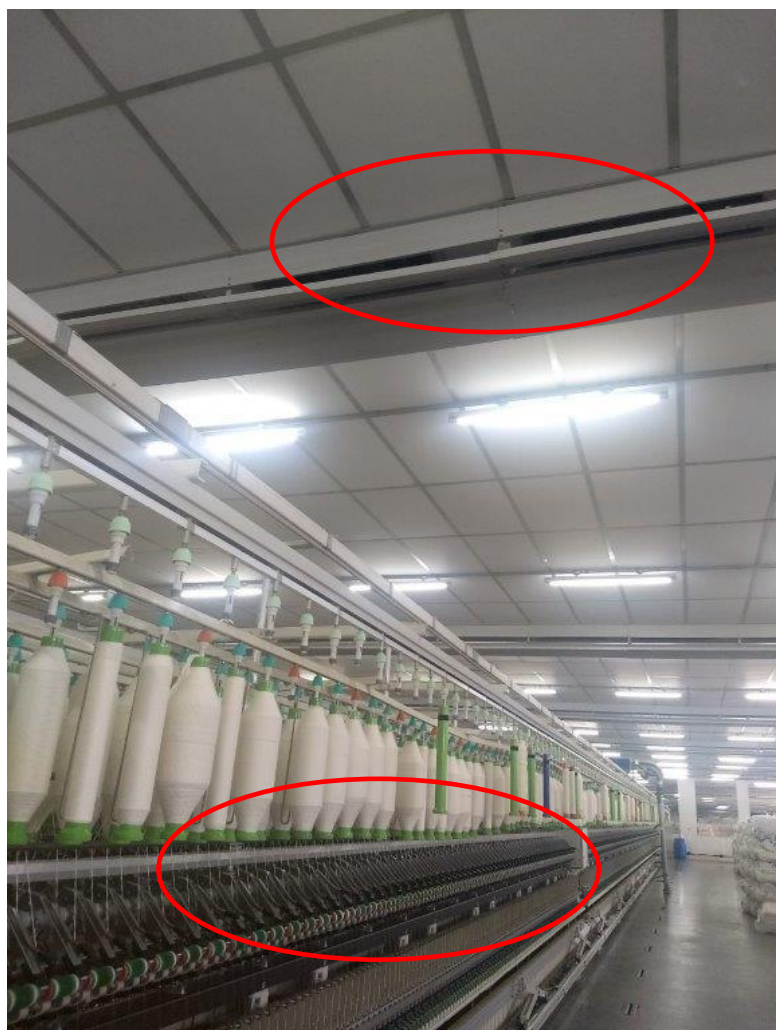
Equipped with this information, the service technician began observing area indicated. Immediately he found that dust and fluffy fiber bundles were falling on to the machine from a defective flap above it.

Fig. 5: Defective flap above the machine, causing dust and fluffy fiber bundles to fall on to the machine.

In this example, the quality problem created by a defective flap might have been overlooked if it was not linked to a very specific yarn problem, such as periodic faults.
