PRACTICAL CASE

High level of yarn count cuts caused by defective drafting aprons in ring spinning

It's vital to find the source of continuous increases in clearer cuts. USTER® QUALITY EXPERT alerts the mill to a problem, and Assistant Q quickly points to the solution...

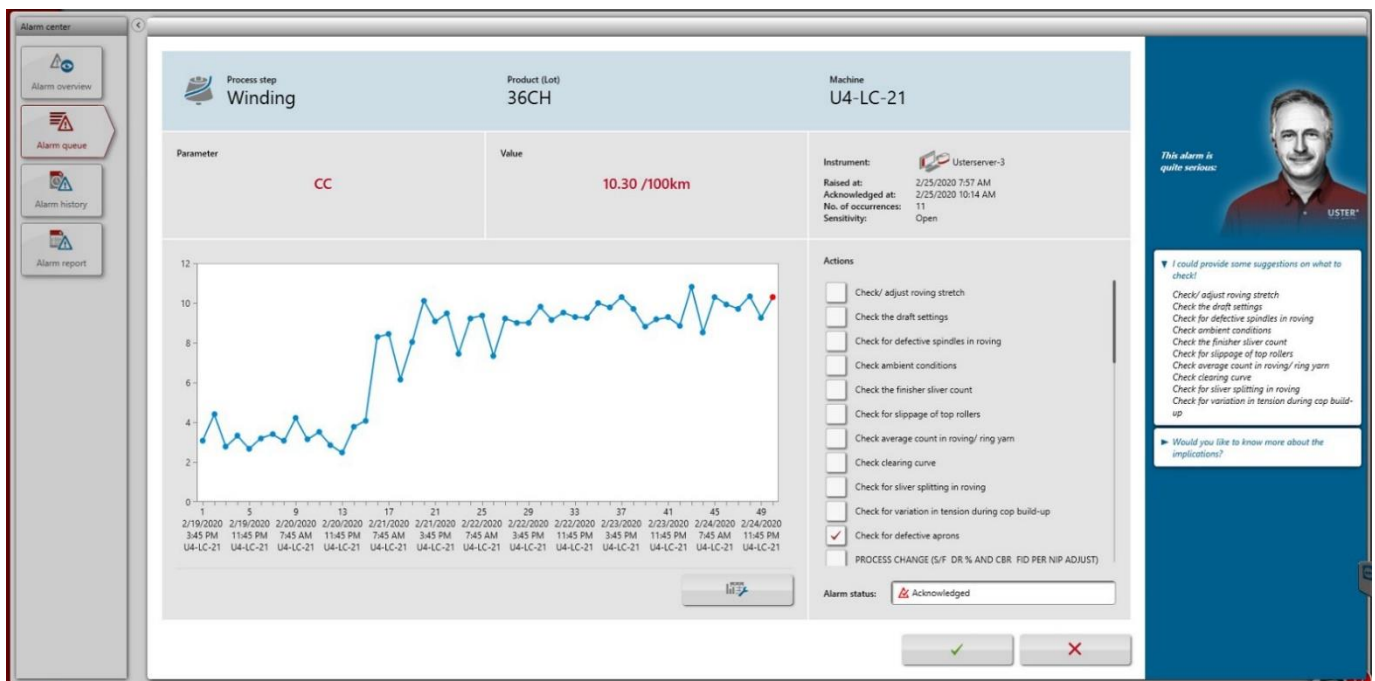
USTER® QUALITY EXPERT Assistant Q triggered an alarm, alerting the user to a high amount of CCp (Continuous Count positive) cuts in winding (Fig. 1).

Fig. 1: USTER® QUALITY EXPERT screen showing the increase in CCp cuts to 8 -12 cuts/100 km.

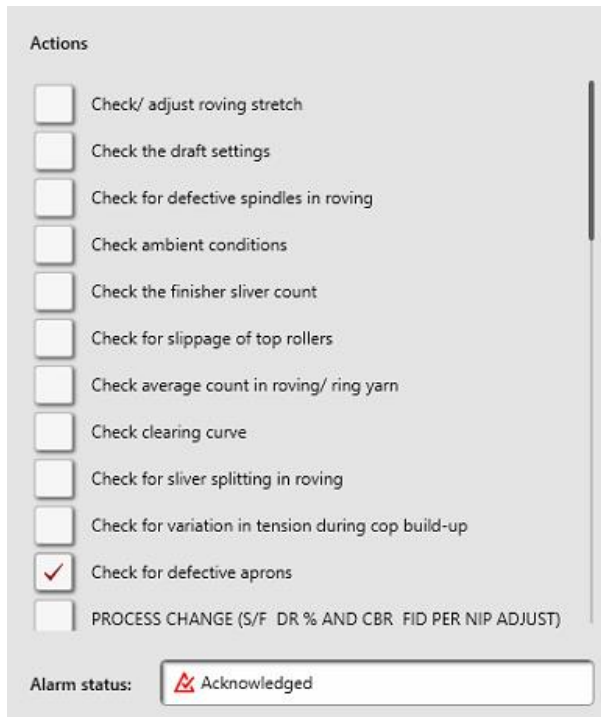
Assistant Q indicated aprons as a potential source – among a few others – of this problem (Fig. 2).

Fig. 2: Assistant Q indication to 'Check for defective aprons' as one of the sources for such problem.

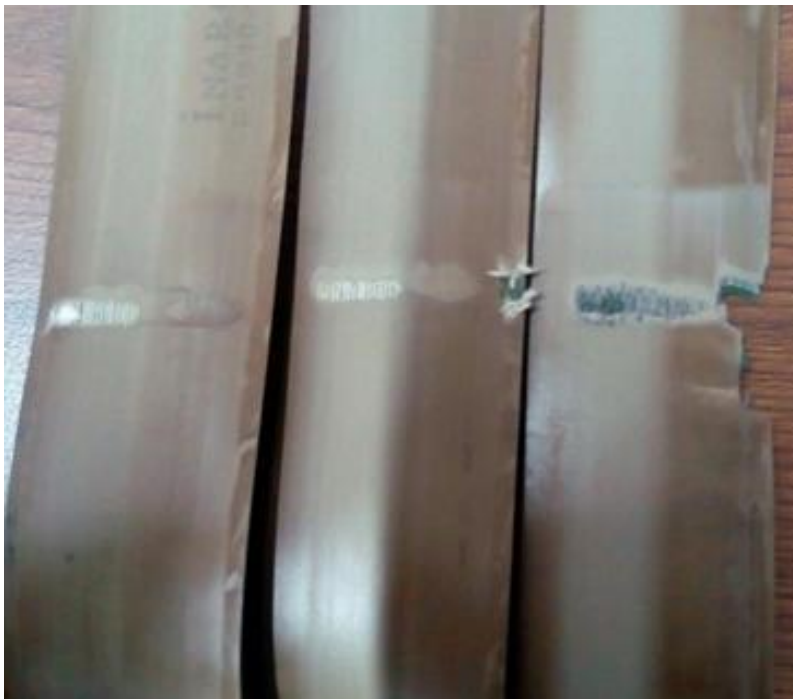
Examining possible differences or issues with this spinning machine, the spinner found that some of the aprons were defective. This was causing long mass variations, thus leading to an increased CCp cut level (Fig. 3).

Fig. 3: Defective aprons which caused long mass variations, leading to an increase in CCp cut level.

The spinner exchanged all the defective aprons and the CCp cuts returned to a normal level (Fig. 4).

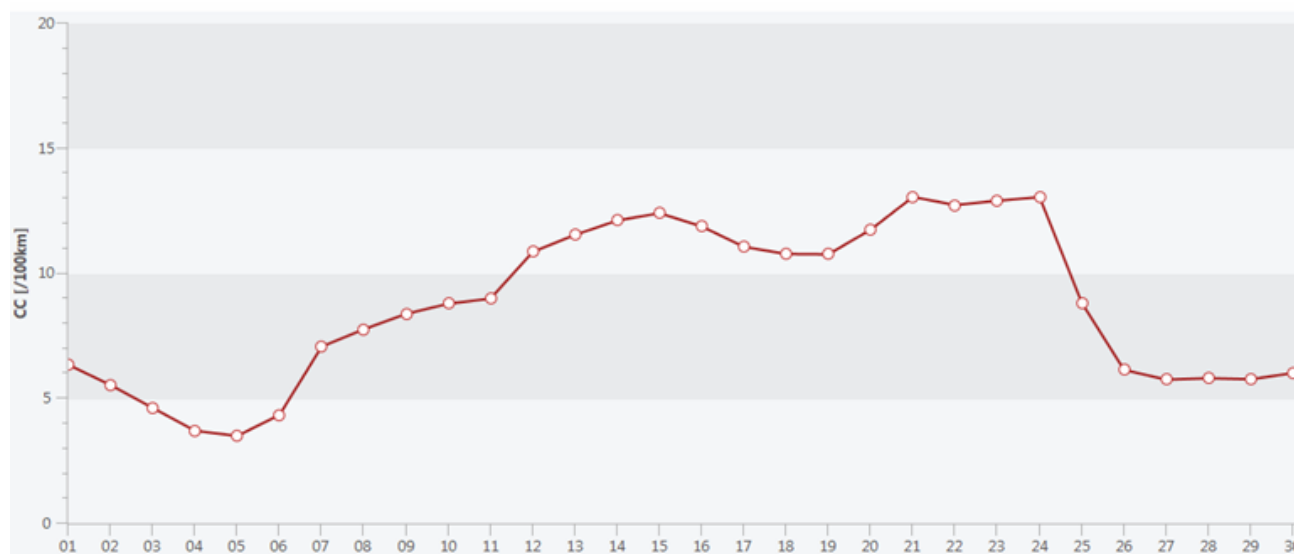
Fig. 4: Graph showing CCp cuts returning to their normal level.
