PRACTICAL CASE

USTER® QUANTUM EXPERT 3 provides data to identify root cause of thin places

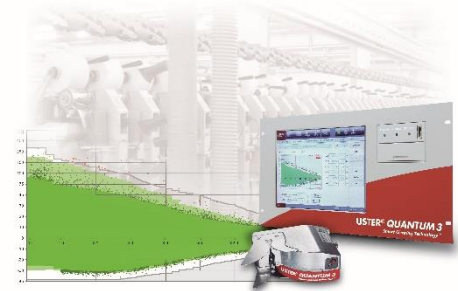
Why would a mill witness, all of a sudden, one of its linked winder producing higher thin place cuts? What could be the root cause of such irregularities? How did USTER® QUANTUM EXPERT 3 help find the source of it?
