PRACTICAL CASE

High level of thin places cuts caused by defective roving machine front roller

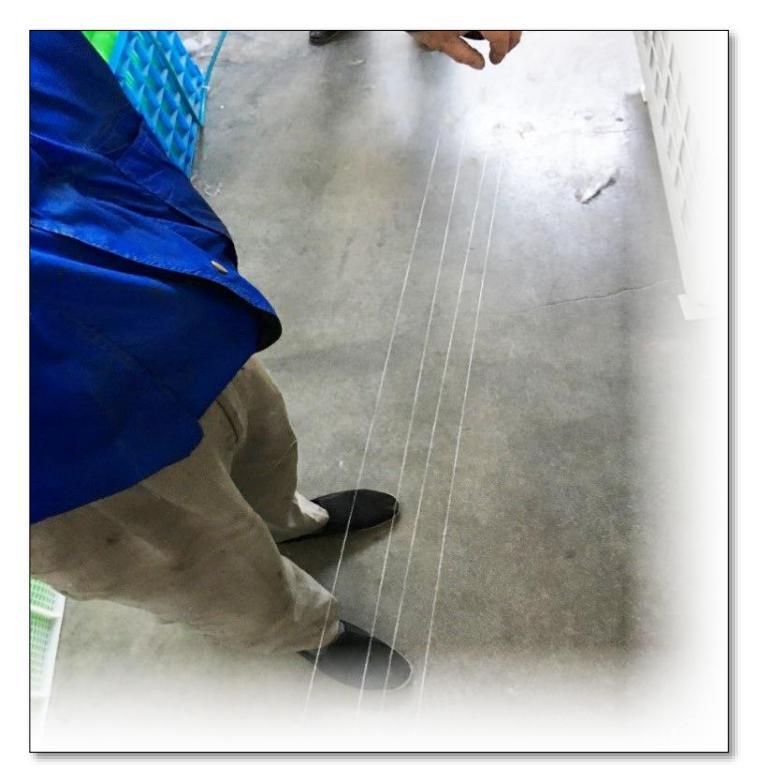
The spinner collected the bobbins with the T alarms to examine them physically. This investigation showed that the thin places were visible and were periodic (Figs. 1 & 2).

Fig. 1: The thin places were visible to the naked eye.

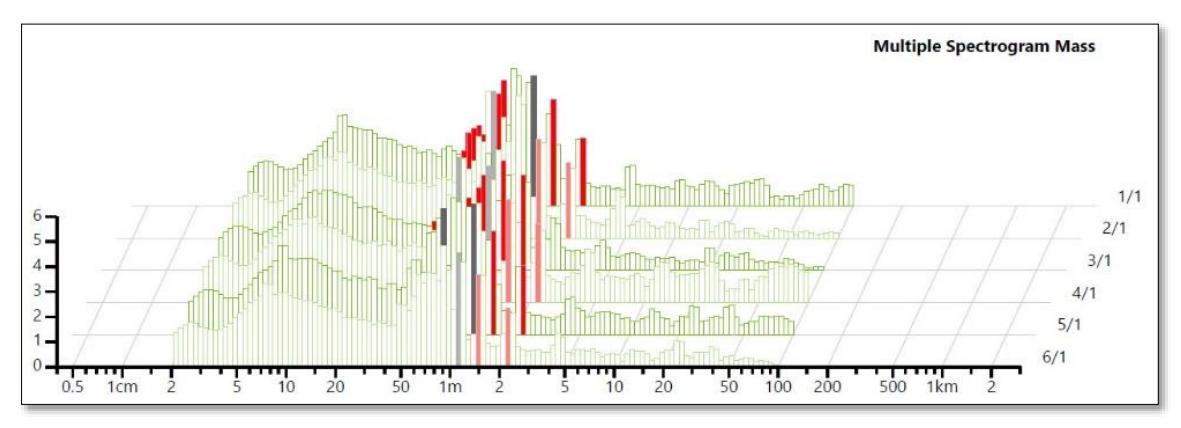
The bobbins were then examined in USTER[®] *TESTER 6* and this verified the periodicity. The characteristics of the harmonics indicated that the problem was originating from the roving machine (Fig. 3).

Fig. 3: Multiple spectrogram mass of USTER* TESTER 6 showing the periodicity of the thin places.

The spinner examined all the spindles of the roving machines supplying material for this yarn. This revealed a defective front top roller on the roving machine, which was exchanged immediately.

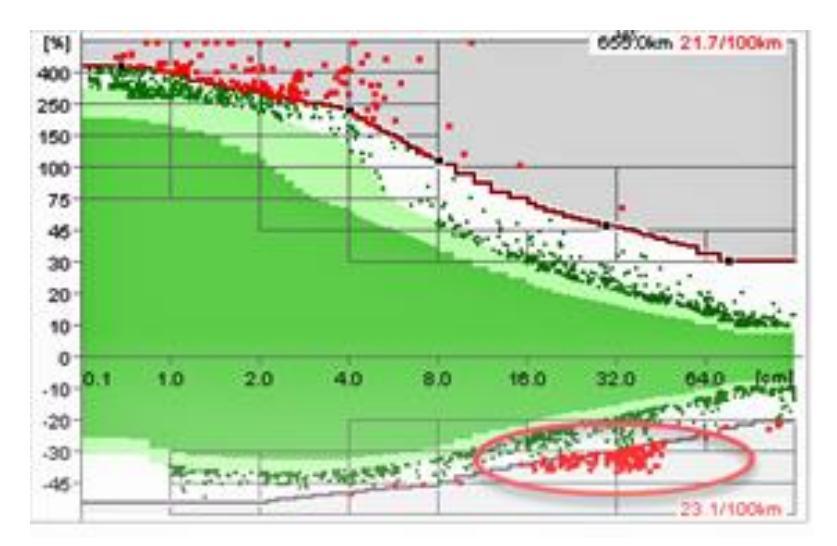
Comparison of yarns from before and after the change to the roving machine confirmed that this was the root cause of the thin places. (Figs. 4 & 5).

Fig. 4: USTER[®] QUANTUM 3 YARN BODY[™] before changing the defective front roller

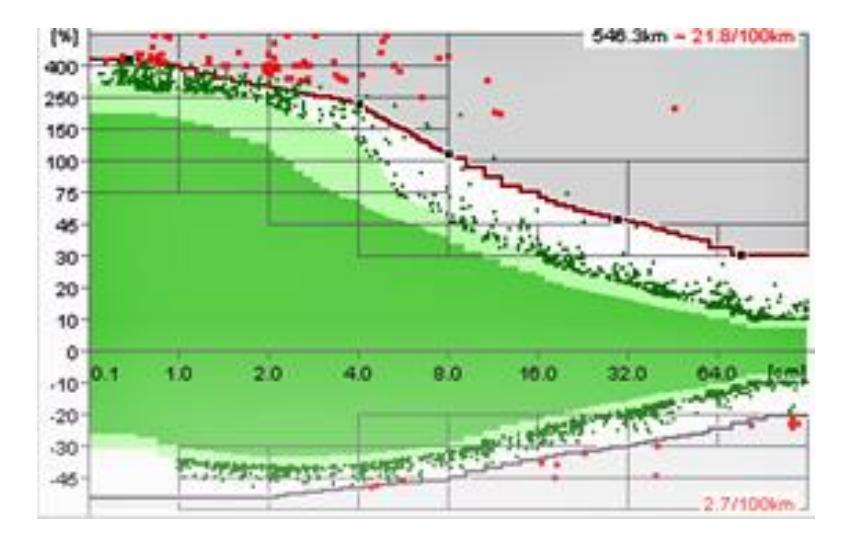
Fig. 5: USTER[®] QUANTUM 3 YARN BODY[™] after changing the defective front roller
